Type A Accident
Investigation Report
of the
June 25, 1997
Contract Inspector Fatality
on the
Satsop-Aberdeen #2 & #3
230 kV Line

B O N N E V I L L E
POWER ADMINISTRATION

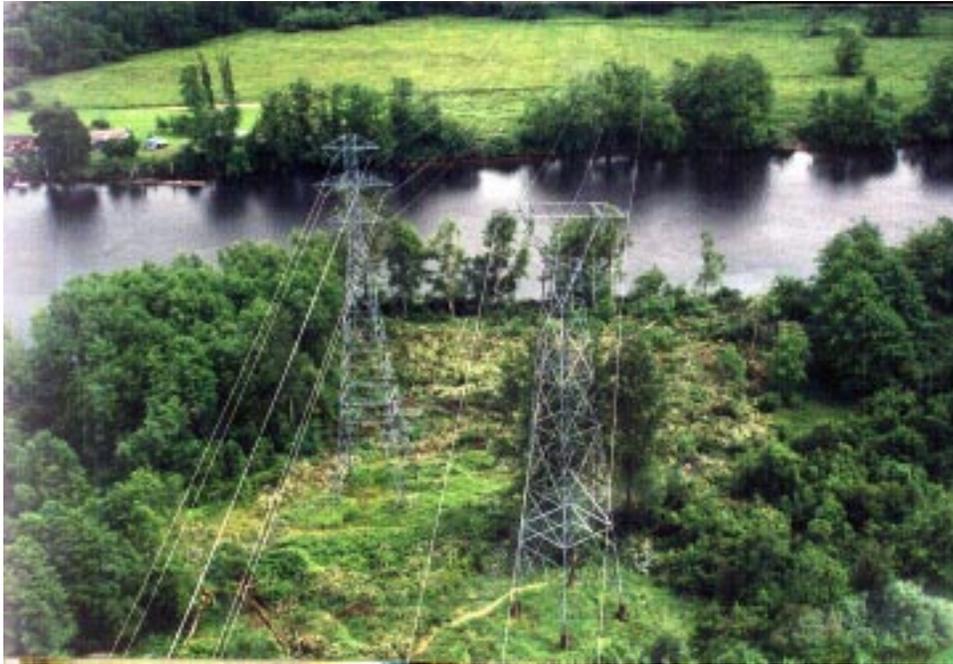
Exhibit 4 - Work Area

through the foreman, told the crew to stop work because they were in the wrong place. He said that the required brush cutting would actually be between the two structures — 8/5 and 8/4 — and the Chehalis River. (See Exhibit 4) The crew then made a pathway into the work area (See Exhibits 5-7) and started cutting brush and trees in the corridor, proceeding from the two structures, BOL,0 south towards the river.

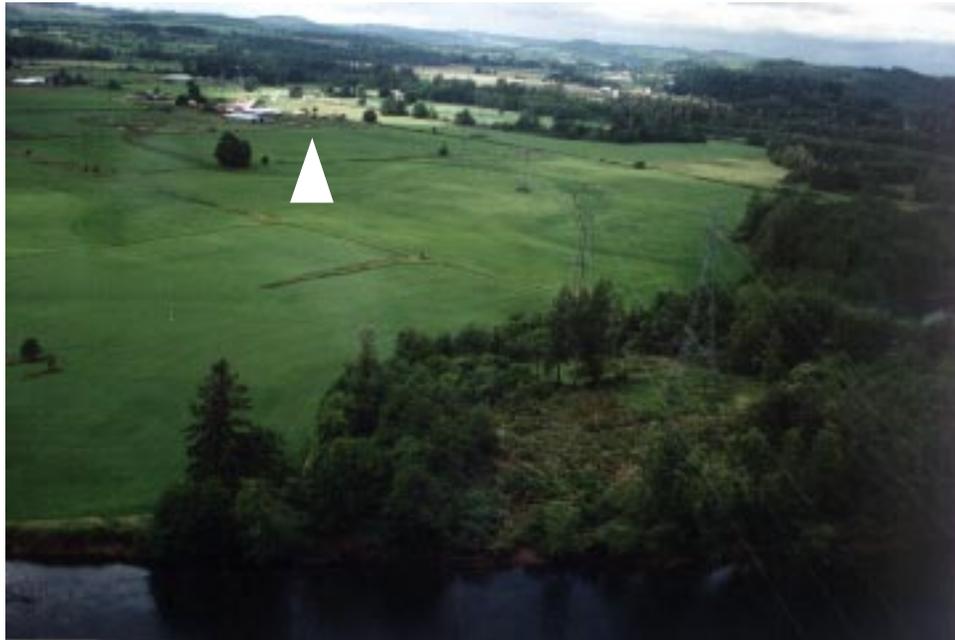
Exhibit 14 - Aerial View of Farmhouse Where 911 Call was Made.

Though the CORRUCO foreman called 911 immediately from the cellular phone in his pickup, he was unable to describe the exact location. He proceeded to the closest farmhouse, 3/4 mile away. There, a resident of the farmhouse contacted 911, Grays Harbor Communications dispatch center, with the exact location, address of the farmhouse and the information that a possible tree-falling injury had occurred. The Montesano Fire Department was dispatched at 1034 hours and arrived at the accident scene at 1043 hours. Emergency medical attention was provided by personnel from the Montesano Fire Department. They notified Airlift Northwest at 1049 hours that an airlift was needed. Airlift Northwest arrived from Seattle at 1132 hours and departed for Harbor View Medical Center in Seattle at 1134 hours. They arrived at Harbor View Medical Center at 1200 hours. The injured inspector was evaluated by Harbor View Medical Center emergency room personnel. Following evaluation, he was moved to the trauma unit and immediately placed on life support. After hearing the findings, conclusions, and recommendations of hospital and medical support personnel, his family decided to terminate life support at approximately 2225 hours. The inspector expired at 2228 hours on June 25, 1997, at the Harbor View Medical Center, Seattle, Washington.
